# CF6 JET ENGINE PERFORMANCE IMPROVEMENT - NEW FAN

W.A. Fasching

GENERAL ELECTRIC COMPANY

NASA Lewis Research Center  
Contract NAS3-20629

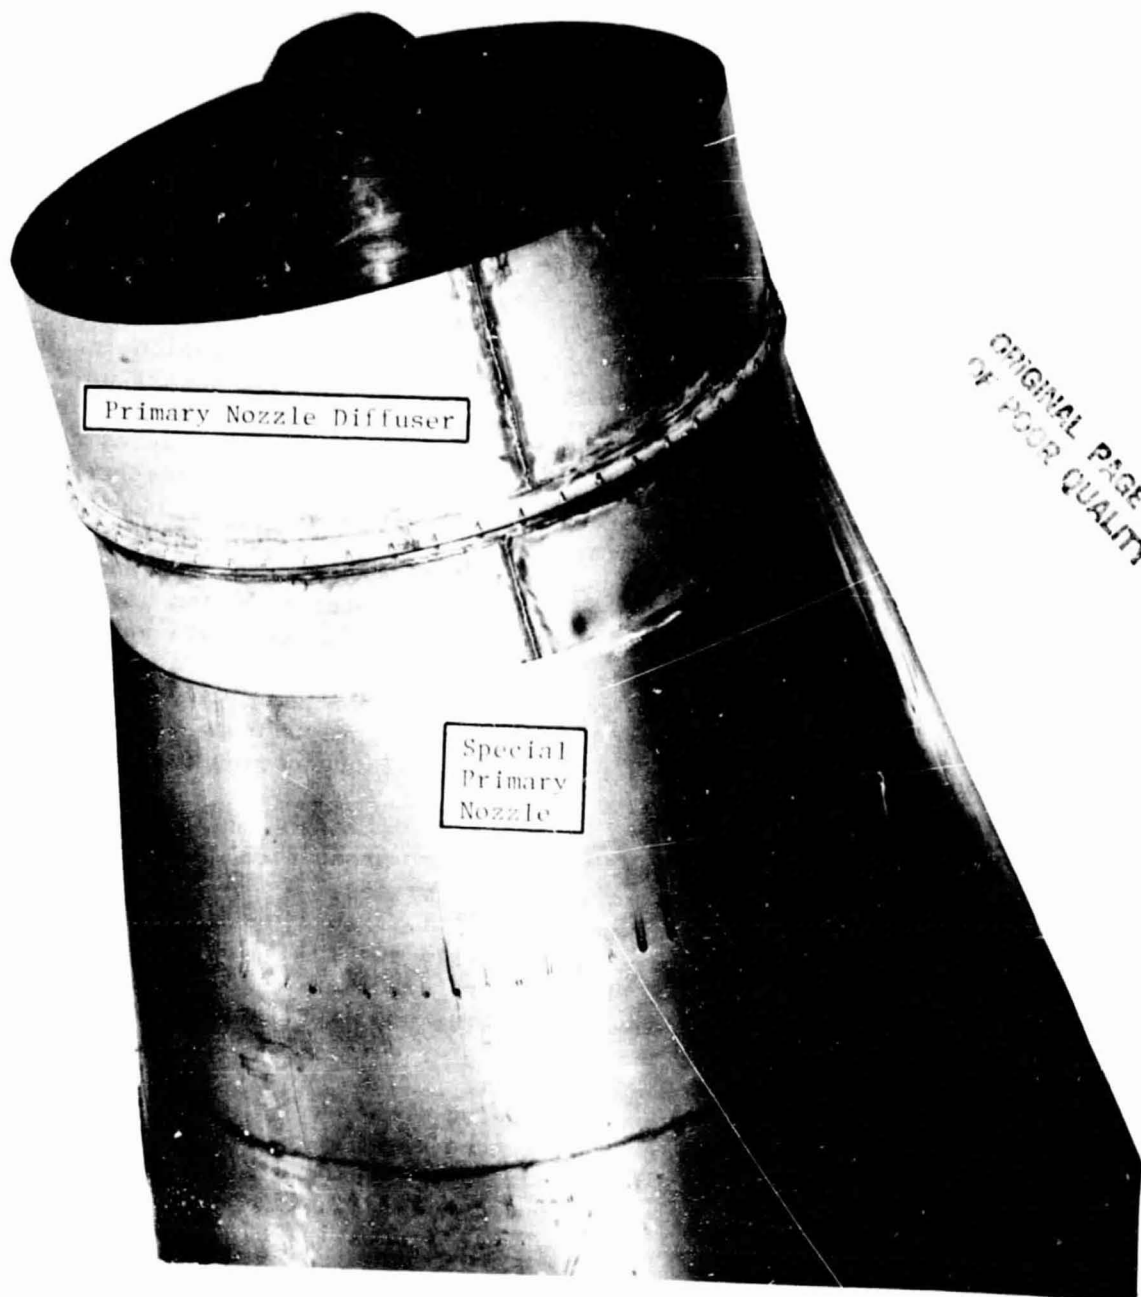
Figure 58. CF6-50 Primary Nozzle and Diffuser for Simulated Altitude Performance Testing.
